## DISTRIBUTING CO., INC.

SERVICE NOTE KDK 2025A MK11

SERVICE NOTES/HINTS AND KINKS

### SERVICE NOTES/HINTS AND KINKS

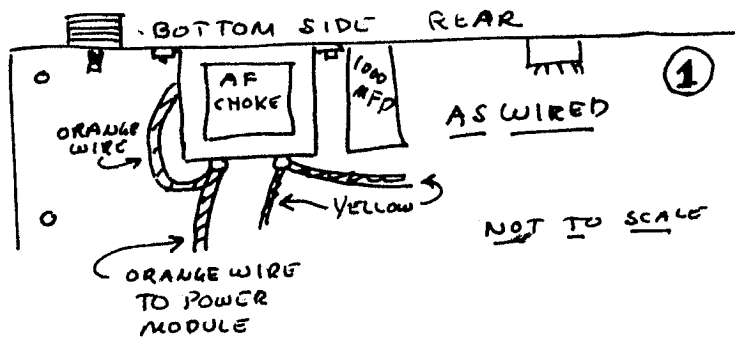
Drawing #1 shows the unit as it comes from the factory. Note that the lugs on the left of the AF choke have two orange wires. One of the wires on the far left goes to the switch. The other orange wire goes to the power module. This wire will be moved to the right lug as shown in figure #2.

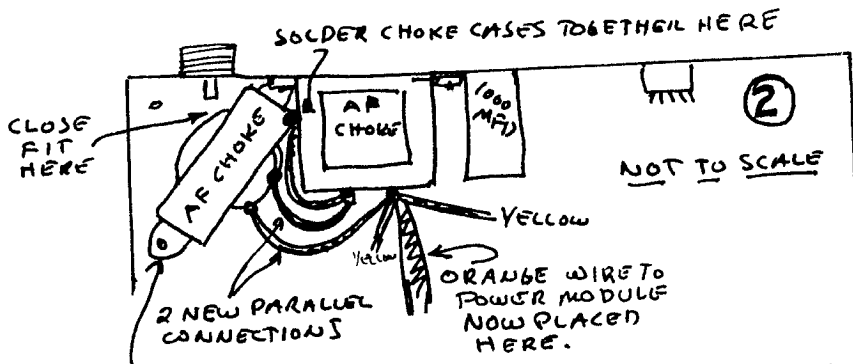
Drawing #2 The second AF choke is placed on the chassis. Rather close fit. It is suggested that the cases of the two chokes be soldered together where they touch. Scrape the enamel from the surfaces to be soldered and tin each first using a good hot iron. The mounting tab on the far left should also be cleaned and soldered first and the protruding bolt as well. Then they will solder well and hold. A longer bolt through the low pass filter unit with a nut on the end holding the new choke in place is to be preferred over soldering the tab to the bolt. Two wires, about 18 guage are now used to wire the lugs of the two chokes in parallel as per drawing. Only the orange wire from the power module is moved and is now soldered to the right lug on the original choke.

SOLDER CASE OF CHOKE TO PROTRUDING BOLT OR - USE LONGER BOLT THRU LO PASS FILTER BOARD AND PUT A NUT ON THIS END TO HOLD CASE OF CHOKE TO CHASSIS

\*BE SURE MODER STICKS TO BOLT AND CHOKE FRAME. USE FILE OR SANDPAPER TO CLEAR SURFACE BEFORE SOLDERING.

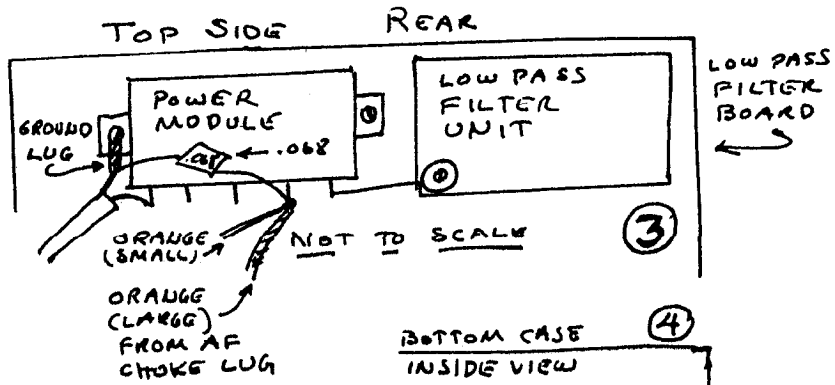
Drawing #3 Place a .068 mfd mylar capacitor of at least 50 volt rating on the wire protruding from the power module which has the orange wire coming from the AF filters and solder in place. Connect the other end of the capacitor to the ground lug bolted on the left hand mounting tab of the power module.

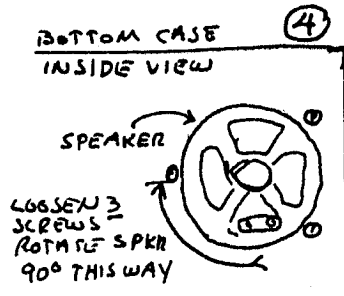
Drawing #4 shows the speaker mounting and how it is turned 90 degrees.

After the choke and capacitor have been installed, loosen the three screws holding the speaker to the outside bottom cover and rotate the speaker 90 degrees inward so that the terminal lugs are now placed on the inside, rather than facing forward or to the rear. See drawing #4. Then retighten the three screws. If the speaker is not moved so that the terminals are placed as shown, the terminals might short against the newly installed choke.
